NASA Contract Report 181898

Boeing / NASA Composite Components Flight Service Evaluation

**Contract NAS1-11668
November 1989**

This is the tenth, and final, progress report on the service evaluation of graphite-epoxy spoilers for 737 aircraft. This effort has been conducted as a portion of NASA contract NAS1-11668, "A Study of the Effects of Long-Term Ground and Flight Exposure on the Behavior of Graphite-Epoxy Spoilers." The program is structured to gather and evaluate actual commercial service experience on a large number of graphite-epoxy spoilers and test specimens in a wide range of operating environments. This is the final report which summarizes the completion of 15 years of flight service.

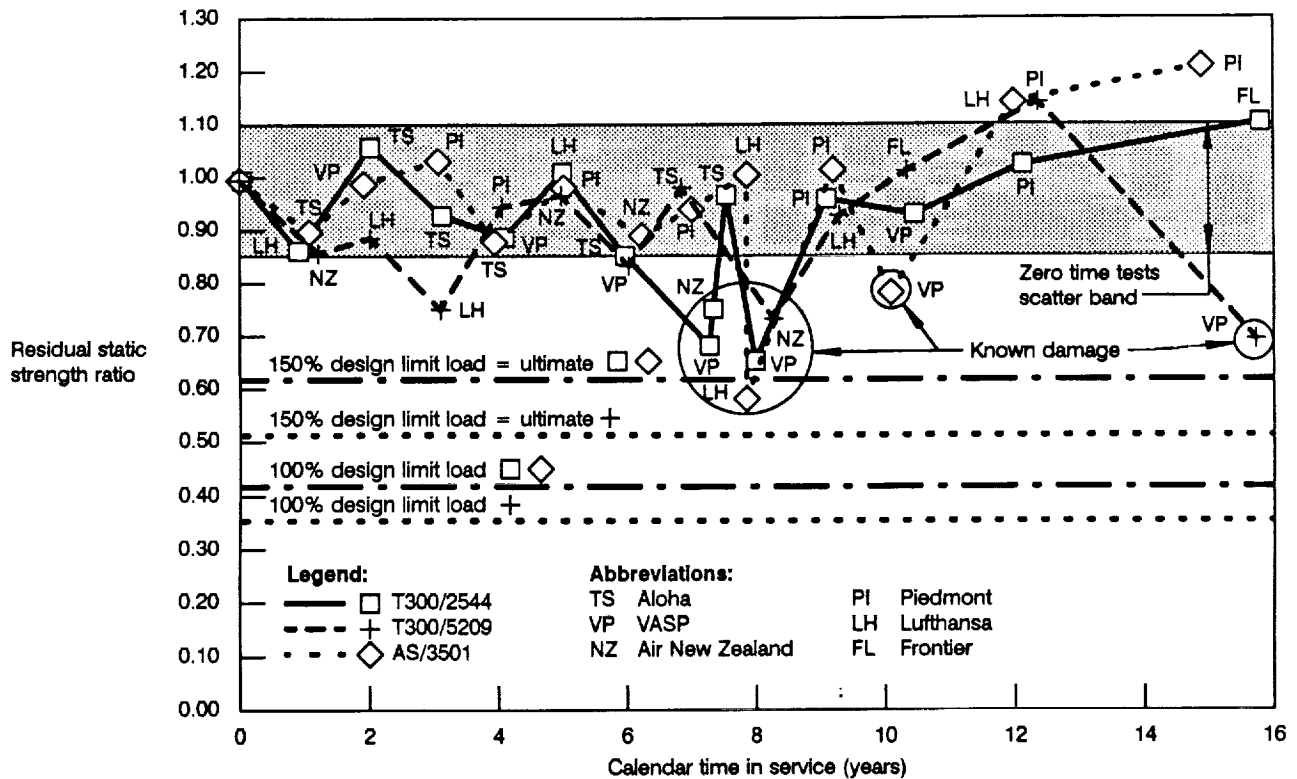
Figure 15. Summary of Residual Strength After Exposure

Data from the tested spoilers are summarized in Figure 14. Figure 15 shows the residual static strength data accumulated for the evaluation period. Each symbol represents one test of a particular spoiler dash number (i.e. type of skin material) after a predesignated period of time. Initials near the symbols indicate the airline from which the spoiler was removed. The data are shown as a residual strength ratio, where 1.0 is the original unexposed certification test value for each material system. The scatter band for a total of 16 ultimate tests run on unexposed -2 units is shown. Although limited to one production run of only one of the three types of material, the band provides some idea of the scatter that could be expected. The limit and ultimate load requirements for each material system are also shown in the figure. Several units have been tested with significant known damage over the course of the program. The damage consisted of exfoliation corrosion blisters at spar to center hinge fitting splice locations. These units all failed above design limit load.

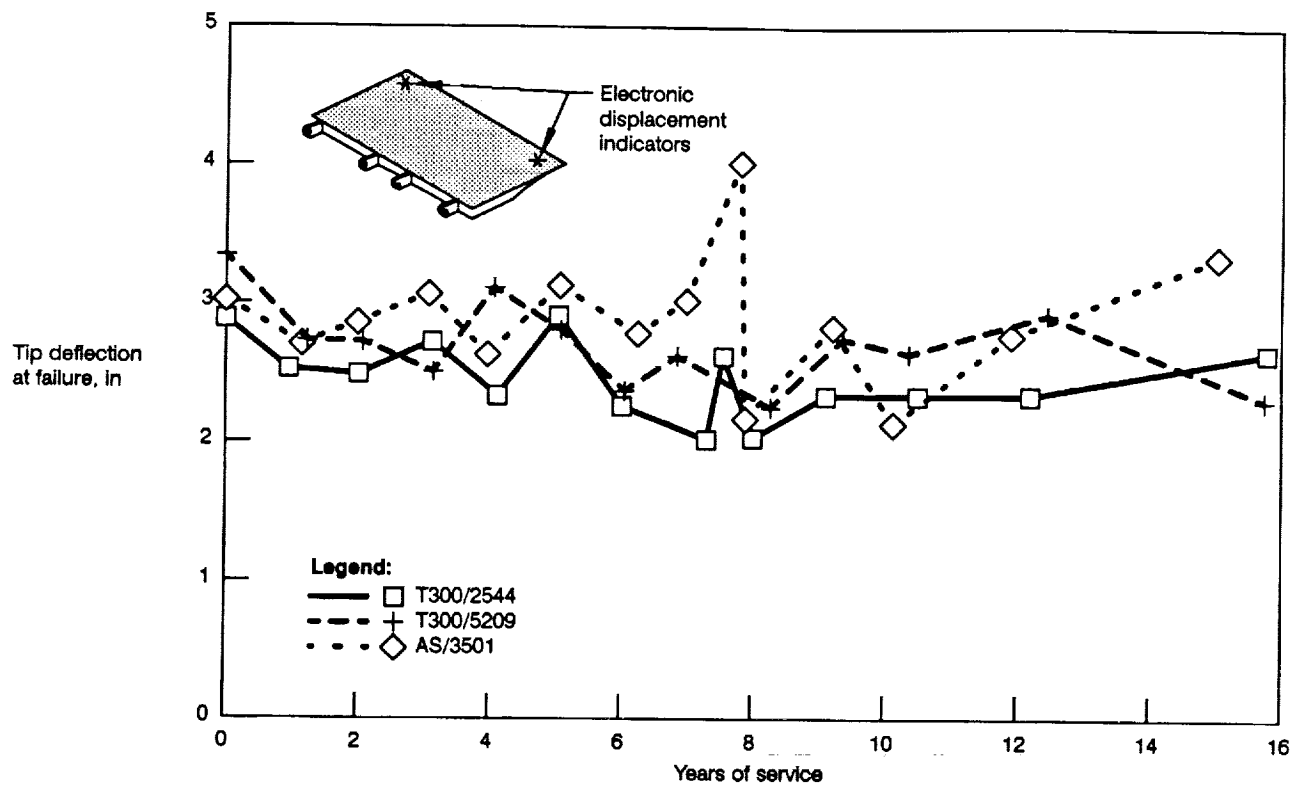
Figure 16. Summary of Spoiler Stiffness After Exposure

Tip deflection at failure for all of the spoilers as a function of exposure time is shown on Figure 16. The tip deflection correlates to panel stiffness.

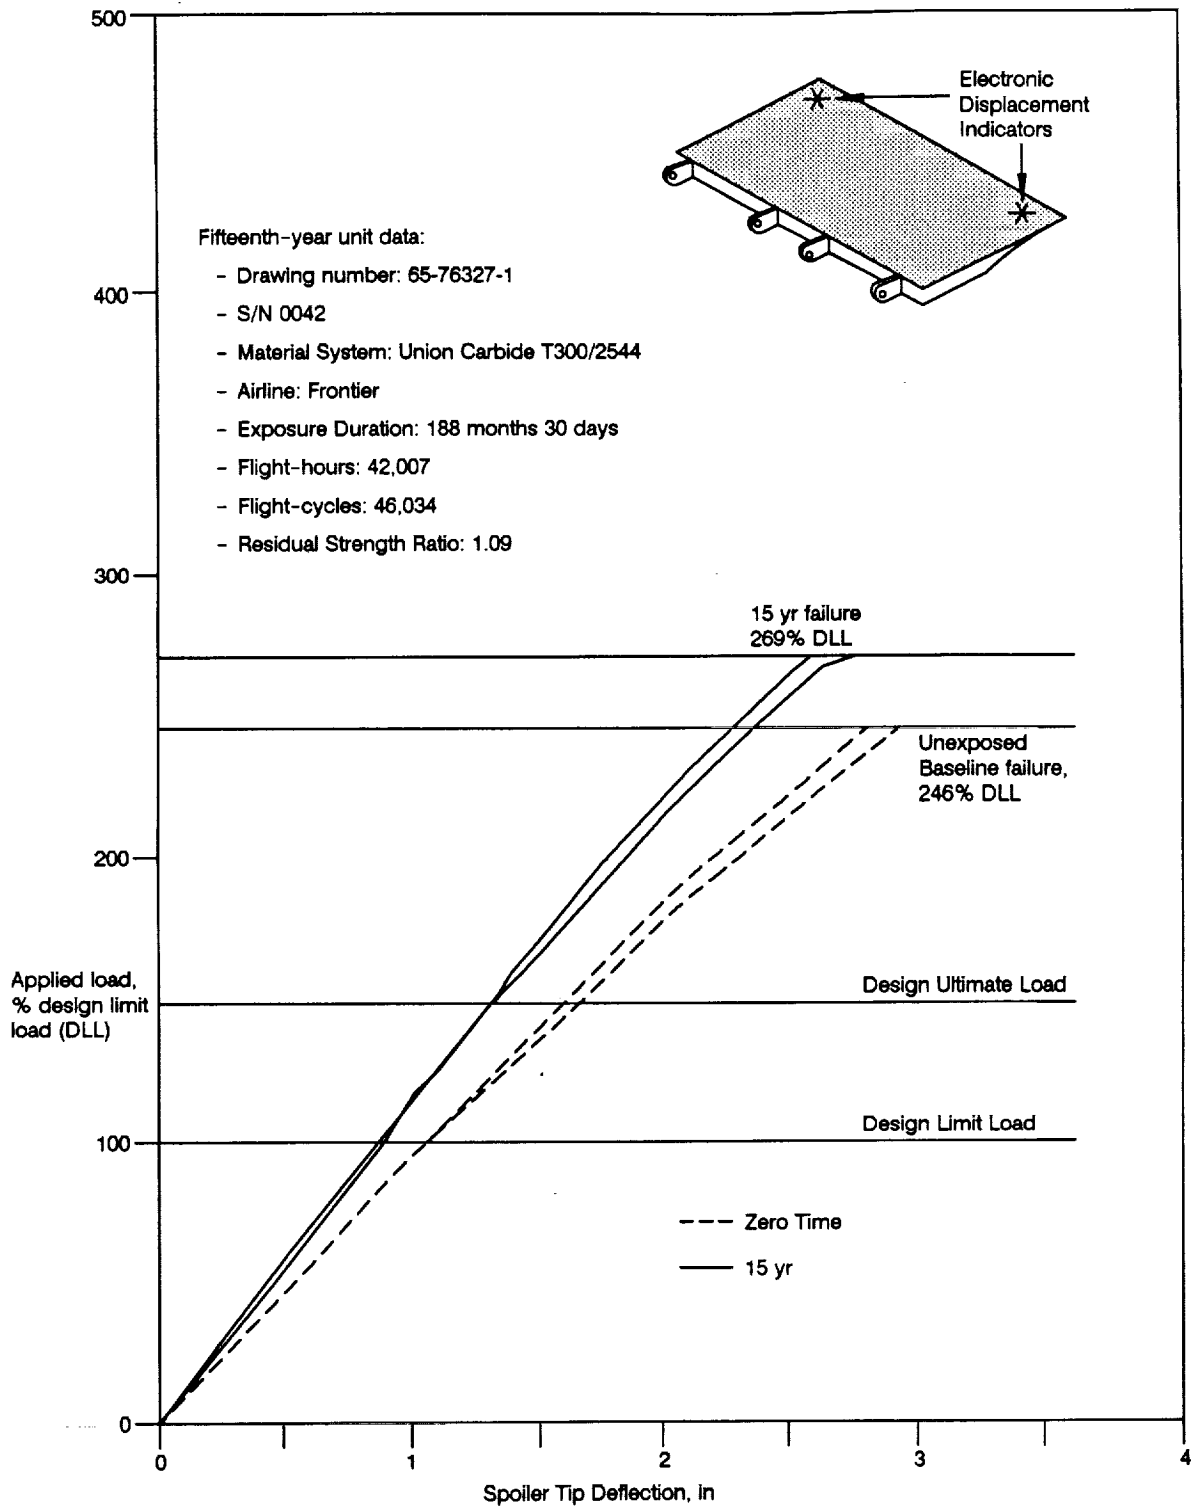
Figure 17. Residual Strength and Stiffness of S/N 0042 After 15 Years of Service

The failure mode of spoilers S/N 0042 and S/N 0117 corresponded to a higher energy failure mode. In each case the center hinge fitting was essentially rammed through the upper surface. A lower energy, less catastrophic, failure mode was evident for S/N 0058. In this mode the failure initiates at a corrosion site and propagates to the center hinge fitting. Photographs of the spoilers after testing are shown in Figures 21 through 26.

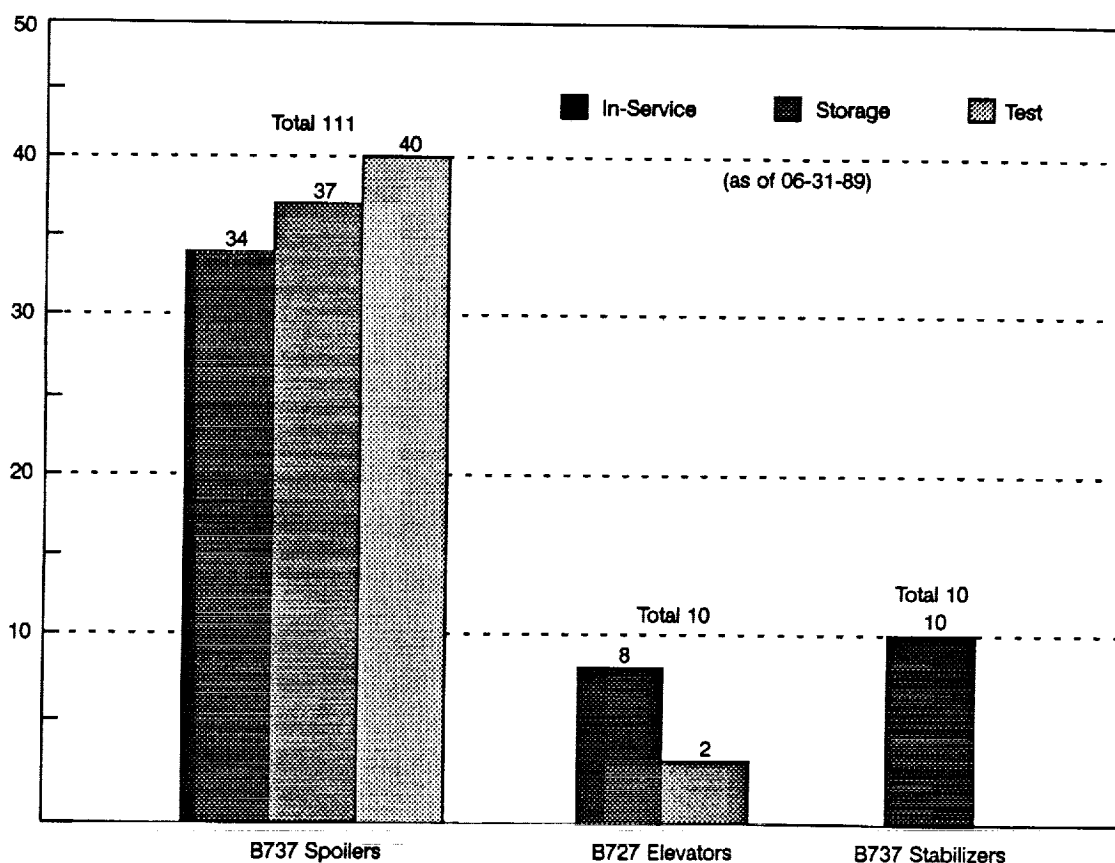
Figure 27. Component Disposition

B737 Spoilers: The unscheduled removal of fifteen spoilers occurred during this reporting period. Data for these spoilers are summarized in Figure 28. The damage follows a pattern of center-hinge-fitting to spar splice disbond with subsequent galvanic corrosion of the aluminum spar and the formation of upper skin disbond "blisters". The trailing edge damage incident was induced by mechanical damage of unknown origin. The disposition of ten spoilers is unknown at this time

B727 Elevators: There have been six reported damage incidents on the B727 elevator fleet. These incidents are summarized in Figure 29. Four reported cases of lightning strike damage were relatively minor and repair activities were conducted with the elevators remaining on the airplane. The de-icer strike on one of the elevators installed on N7460U resulted in skin punctures that required removal of the elevator for repair access. One elevator was damaged, with several skin punctures, during a ground handling

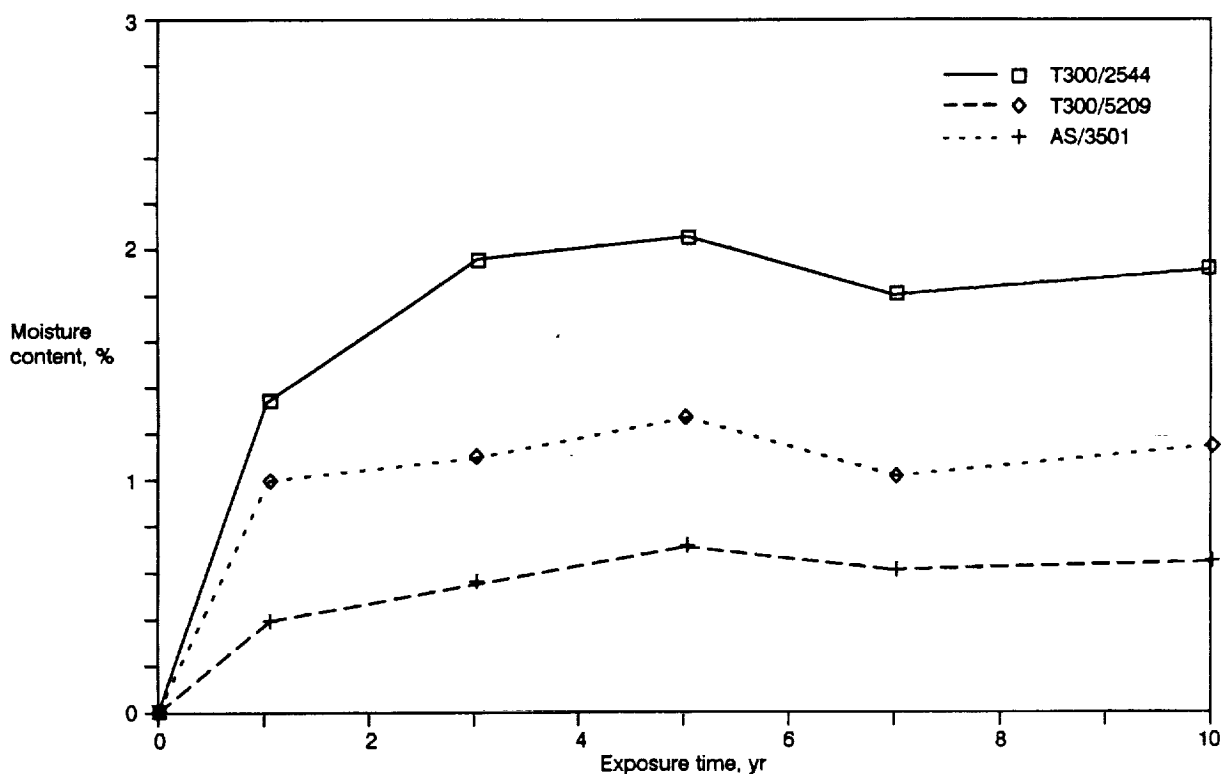
Figure 31. Average Moisture Pickup After Outdoor Exposure at Six Worldwide Locations

The average moisture pickup for the six exposure locations is plotted in Figure 31. The T300/2544 specimens absorbed about two percent moisture, the AS/3501 specimens absorbed about one percent moisture, and the T300/5209 specimens absorbed about 0.6 percent moisture during the 10-year exposure period. Since most specimens are not painted, the outer plies of the material were degraded by ultraviolet radiation. Scanning electron micrographs indicate that all the fibers are coated with epoxy for the unexposed specimens, whereas individual fibers can be seen on the 10-year exposure specimens after the surface layer of epoxy resin was leached away by ultraviolet radiation. Close examination of the three materials indicates that the T300/2544 material is the most susceptible to the degrading effect of ultraviolet radiation. It should be noted that a coating of polyurethane aircraft paint will protect the material from ultraviolet degradation.

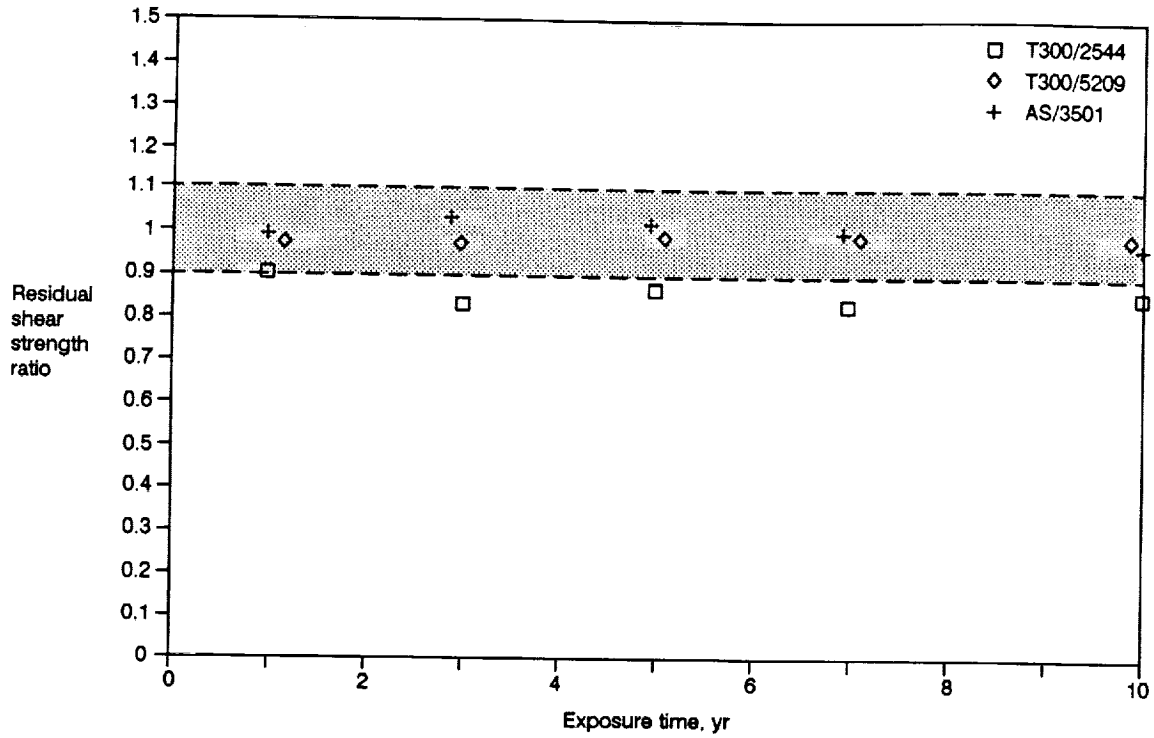
Figure 32. Average Residual Shear Strength After Outdoor Exposure at Six Worldwide Locations

The average residual strength ratios for the shear, flexure, and compression specimens are plotted in Figures 32, 33, and 34, respectively. These values represent a comparison of the average strength values for all six exposure sites with the average baseline strength value for that material system. A $\pm 10\%$ bandwidth, which represents the strength scatter in the baseline specimens, is shown on each figure. The shear strength ratios are within the scatterband except for T300/2544, which is slightly below the baseline value. For the flexure specimens, Figure 33, the strength of the T300/2544 material was slightly below the scatterband after 10 years of exposure. The flexure strength for the AS/3501 material has been consistently above the baseline strength since the first year tests. These results indicate that the baseline strength may be low. To investigate this possibility, eight spare AS/3501 flexure specimens that had been stored in an office for 10 years at NASA Langley were tested. The average failure stress for these

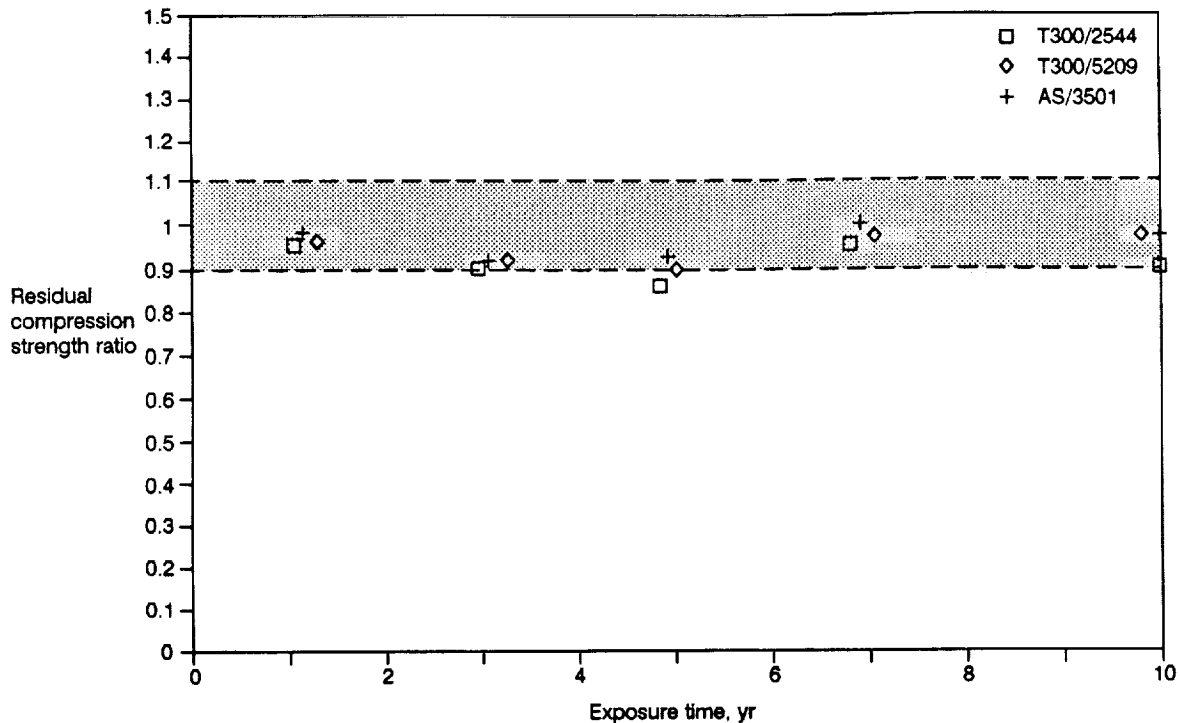
Figure 34. Average Residual Compression Strength After Outdoor Exposure at Six Worldwide Locations

specimens was 18 percent higher than the failure stress for the baseline specimens. These results confirm that a larger number of specimens should have been tested to establish the baseline strength. For the compression specimens, Figure 34, the strengths for all materials are within the scatterband or slightly below the scatterband.
